Memo: City of Statesboro, Stormwater Masterplan Update, March 2021

RE: Completion of Task Order No. 04: Preliminary Stream Restoration Assessment and Update for the City of Statesboro Stormwater Masterplan

Introduction & New Project Assessment

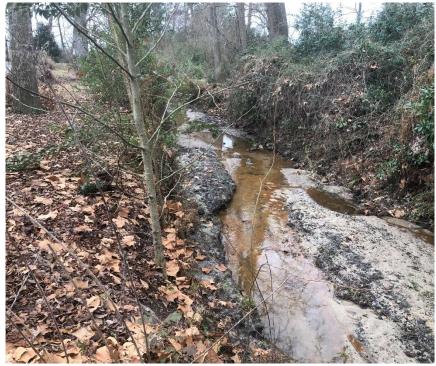
Phase I of the E. Grady Street city park stream restoration looking downstream.

The unnamed tributary flowing through the City park, along Blind Willie McTell Trail, just south of E. Grady Street exhibits significant aggradation of sediment within the stream channel and erosion along the stream banks. The proposed project is divided into two phases, which are delineated by an associated railroad crossing, so that it can be completed in steps if full funding is not available. Thick, unsightly vegetation exists within the riparian corridor for Phase I (north).

The primary focus of the project is to utilize Priority 3 stream restoration techniques to address aggradation and bank erosion issues associated with the tributary. Additional project components include an aesthetically pleasing yet functional planting scheme with an educational component for visitors of the park. Identified permitting includes a Nationwide Permit through the U.S. Army Corps of Engineers and a Buffer Variance through the GA Environmental Protection Division.

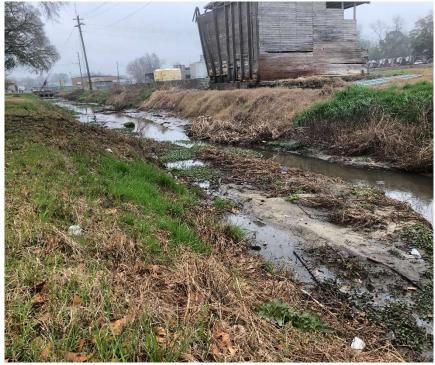
Downstream view of the canal adjacent to Luetta Moore Park.

The canal adjacent to Luetta Moore Park requires dredging due to aggradation of sediment in the channel bottom. In addition, the banks experience sloughing despite being vegetated. It is also noted that beaver activity takes place upstream of the project site. A linear utility runs parallel to the canal, limiting the ability to alter the bank slope or flow path of the canal.

The primary project goal shall include providing Priority 4 Restoration (in-place stabilization) to address the erosion and sediment issues within the channel. The regraded bank will require vegetation or hardarmoring (such as rip-rap or Flexamat). In addition, adjacent properties shall be reviewed to determine if an adjacent land use is contributing heavy sediment loading to the canal. Finally, the beaver population upstream shall continue to be controlled to reduce upstream damming. Identified permitting includes a Nationwide Permit through the U.S. Army Corps of Engineers and a Buffer Variance through the GA Environmental Protection Division. The project exists within a regulatory floodway so a no-rise engineering analysis will be necessary to satisfy National Flood Insurance Program requirements.

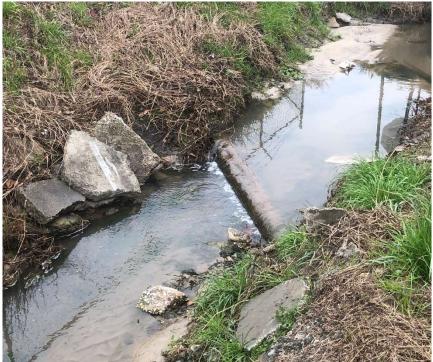
General view of exposed utility line.

The canal adjacent to Martin Luther King Jr Drive (just north of W Main Street) contains an exposed utility line that is subject to the energy exhibited at base flow of the canal. This energy may negatively impact the lifespan of the utility line. In addition, the canal contains steep side slopes with sporadic armoring comprised of construction and demolition debris.

The primary goal of this project shall be to protect and stabilize the exposed utility line by constructing a rock structure (such as a cross vane or j-hook) in order to promote channel material to cover the exposed line. In addition, the cost estimate provided includes removal of existing construction and demolition debris occupying the channel and performing bank stabilization using denser armoring such as riprap or Flexamat. Identified permitting includes a Nationwide Permit through the U.S. Army Corps of Engineers and a Buffer Variance through the GA Environmental Protection Division. The project exists within a regulatory floodway so a no-rise engineering analysis will be necessary to satisfy National Flood Insurance Program requirements.

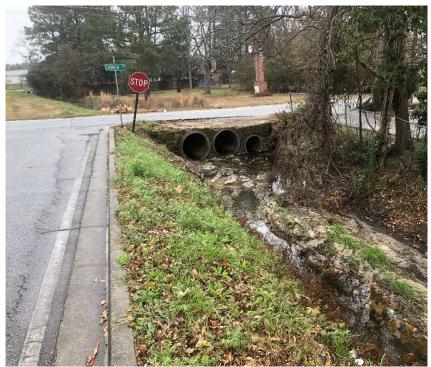
Upstream view of ditch.

A tributary to Little Lotts Creek flows adjacent to a stretch of Van Buren Street and exhibits excessive sediment loading and bank erosion. The watercourse exists between a road and residential neighborhood, so the option to alter the bank slope and/or flow path of the channel is not present.

The primary project goal shall include stabilizing the stream in-place using Priority 4 restoration techniques. In summary, armoring to the existing streambank will be provided utilizing rip-rap or Flexamat. Identified permitting includes a Nationwide Permit through the U.S. Army Corps of Engineers and a Buffer Variance through the GA Environmental Protection Division. The project exists within a regulatory floodway so a no-rise engineering analysis will be necessary to satisfy National Flood Insurance Program requirements.

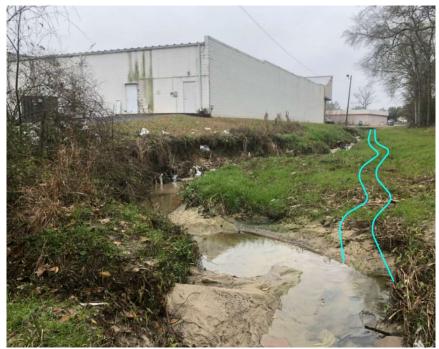
Upstream view of project site.

The proposed project includes addressing bank erosion and sediment aggradation issues associated with a tributary to Mill Creek. The stream is experiencing excessive erosion and sloughing on its banks. In addition, the eroded bank shown above is encroaching onto an adjacent parking lot and associated hydrologic structures.

Project goals include utilizing natural channel design techniques (Priority 2 Restoration) to construct a new, stable channel within the available left floodplain overbank at the existing channel elevation. By utilizing this technique, the new channel will be moved from potentially impacting the adjacent parking area while also reducing sediment loading downstream. Identified permitting includes a Nationwide Permit through the U.S. Army Corps of Engineers and a Buffer Variance through the GA Environmental Protection Division.

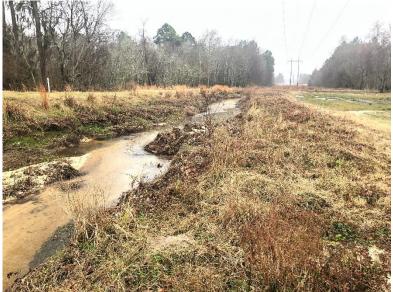
Downstream view of Gentilly Canal.

The drainage canal at Gentilly Road collects drainage from the majority of the city. Within the vicinity of the Statesboro Waste Water Treatment Plant, Gentilly Canal exists within a powerline easement and exhibits significant erosion within the stream channel resulting in aggradation of sediment. It is recommended that portions of the stream bank are stabilized through stream restoration techniques.

Initially, an in-depth assessment of the canal shall be performed utilizing the Bank Erosion Hazard Index (BEHI) to identify problem areas within the canal. Once identified, stream restoration measures shall be designed to address the erosion issues and to increase the overall stability of the canal. In addition, the existing maintenance road within the easement should be improved with gravel to provide ease of access for maintenance. Property may have to be purchased or easements obtained to complete the project, depending on the areas of interest identified. Identified permitting includes a Nationwide Permit through the U.S. Army Corps of Engineers and a Buffer Variance through the GA Environmental Protection Division. The project exists within a regulatory floodway so a no-rise engineering analysis will be necessary to satisfy National Flood Insurance Program requirements. There may be additional permitting components of this project as wetlands are suspected to be adjacent to the canal.

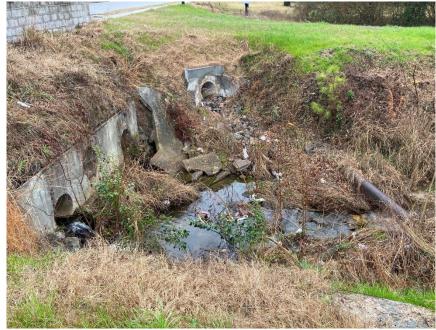
Example utility crossing just south of Donnie Simmons Way.

During the site tour, there were several exposed utility crossings observed to be causing debris blockages or scour in the stream bed. The energy on the utility lines may also negatively impact the lifespan. As a result, an additional project was recommended to assess the condition of utility crossings citywide. Utility lines can be protected and stabilized using a rock structure (such as a cross vane or j-hook) in order to promote channel material to cover the exposed line.

This assessment can be completed as a GIS mapping exercise where water and sewer infrastructure are overlaid on the ditch and stream/canal layer to locate all utility crossings. Once mapped, each site should be inspected to identify utility vulnerability and whether the elevations are conducive for stream restoration structures to provide build-up of sediment to cover exposed utility pipes. Construction of the most vulnerable and suitable locations is easy to get permitted through an emergency permit.

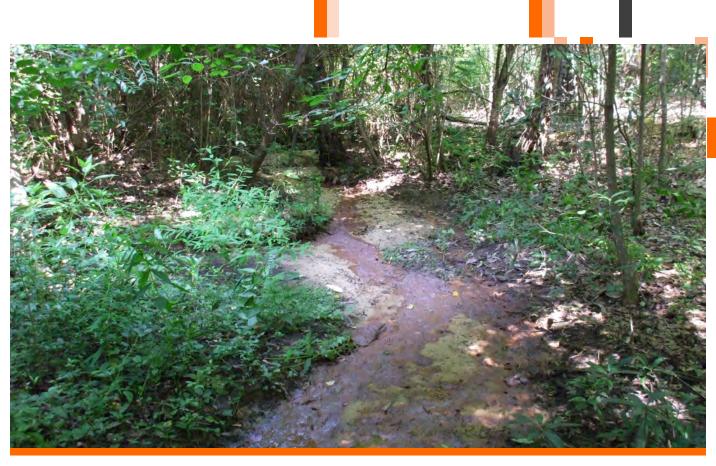
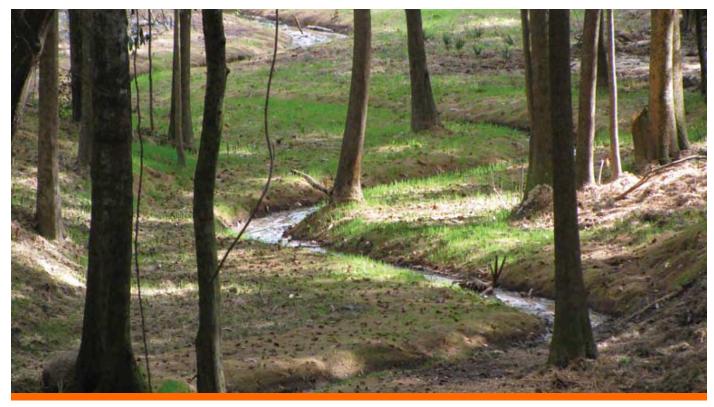
Troy University stream restoration in Janice Hawkins Park. The EPA 319-funded project consisted of Priority 2 natural channel design restoration techniques.

Troy University developed Janice Hawkins Park as a buffer to the City of Troy. Janice Hawkins Park is a series of ravines filled with large oaks, tulip poplar, pines and red maple and wetlands. The area is home to diverse wildlife and habitat for birds. GMC provided design for invasive species removal and stream restoration within the 20-acre park. One measure of the park's success is demonstrated by students choosing it as the location to make a marriage proposal.

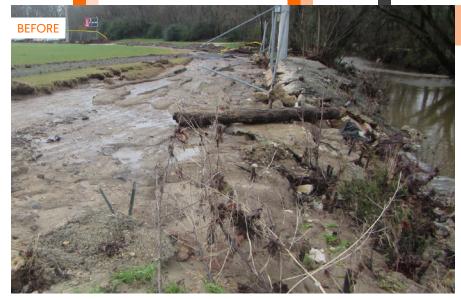
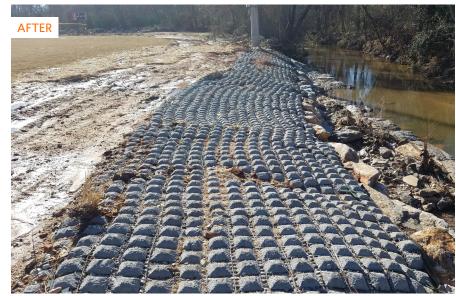
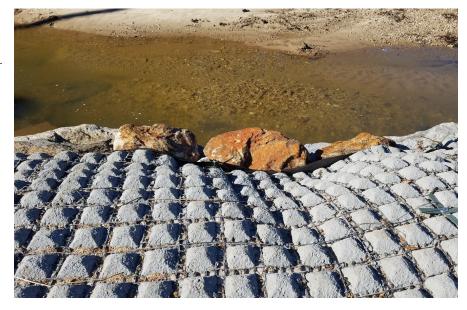
MWWSSB Sewer Line Crossing Stabilization Montgomery, Alabama

GMC was hired to implement an emergency stabilization of a 42-inch sewer main located along 3-Mile Creek in Montgomery, Alabama. The stream has a drainage area of approximately 11.7 square miles and drains the north central portion of the City of Montgomery. The sewer line is a main truck line from the City of Montgomery to the Treatment Plant, located north of the City of Montgomery. The sewer main was exposed, suspending approximately 2 feet from the channel bottom, with a scour pool downstream approximately 4 feet deep. The sewer main was in jeopardy of failing due to high stream flows and increased pressure on the pipe. GMC was able to stabilize the stream to create a permanent grade control structure without having to replace the pipe. This technique not only alleviated the failing condition

of the sewer crossing, but stabilized the stream bed to prevent future degradation.

The approach for the project included a reach-wide stream assessment to determine proper channel dimension and profile based on watershed characteristics and local reference data. The appropriate channel dimension was used to size the rock cross vane structure and rock j-hook structure. The profile data was used to determine the appropriate spacing for the two structures. Spacing of the structures is essential in setting the stream on a path to repair itself. To effectively protect the sewer line, the stream needs the proper amount of room to dissipate its energy in scour pools while maintaining enough energy to carry the sediment load from upstream through the system.

- MWWSSB Sewer Line Crossing Stabilization
 - o *Example*: Utility Stabilization.
 - <u>Applicable Site</u>: Martin Luther King Jr. Drive Utility, and Utility Crossing Assessment
